## San Miguel Community Services District

### Equipment & Facilities Committee Meeting

Friday, February 17, 2017  
9:30 AM

## San Miguel Community Services District Equipment & Facilities Committee Staff Report

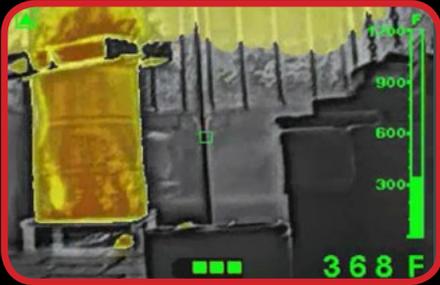
## Super Red Hot

With Super Red Hot colorization, objects are colorized yellow starting at 500° progressing to red at 1000°.

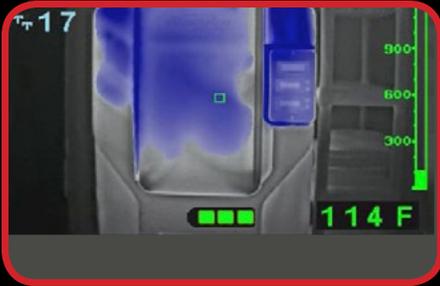
## Electronic Thermal Throttle

When Electronic Thermal Throttle is engaged, hotter objects are colorized blue, isolating areas of potential concern.

The patented **Electronic Thermal Throttle® (ETT)** pinpoints heat sources in scenes. Beneficial in operations such as size-up, overhaul, and hazmat, ETT saves time and effort by quickly identifying problem areas that could otherwise become active fire or rekindles.

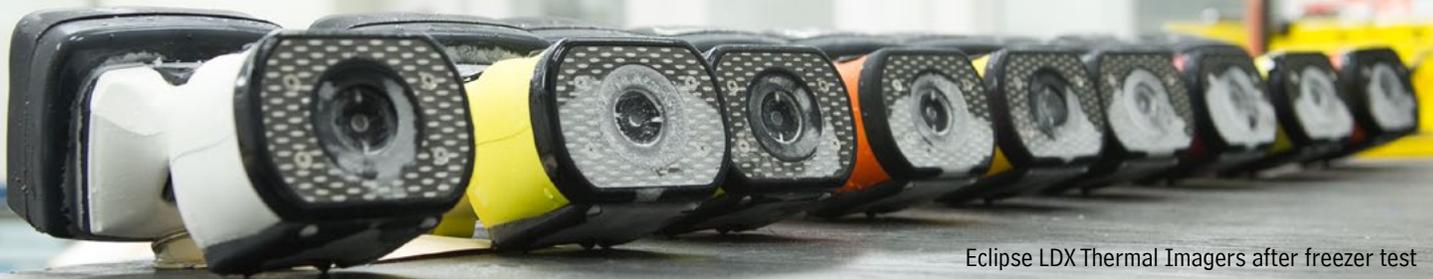
Eclipse LDX Thermal Imagers after freezer test

Long before any industry consensus standard emerged, Bullard TIs were enduring torture test after torture test to ensure their ruggedness for firefighting. Bullard TIs are subjected to repeated drops on concrete, tested in the harshest environmental temperature extremes, and committed to countless hours in real burn conditions. Nothing goes to market that doesn't first meet the standard, Bullard Tough!

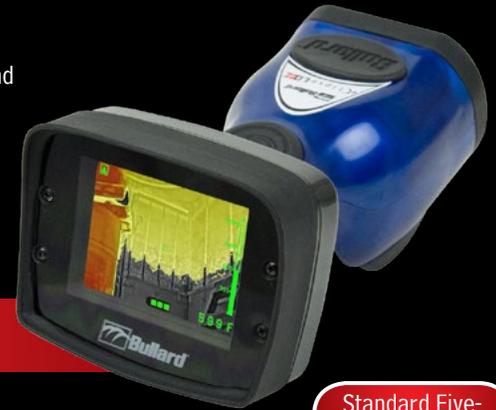
## T3X

A traditional handheld favorite is now equipped with the newest state-of-the-art infrared engine technology for the highest quality performance. Now weighing only 2.5 lbs., the T3X is lighter and smaller than most competitive thermal imagers.

- 240 x 180 or 320 x 240 resolutions
- Equipped with ICE image processing technology for greater image clarity
- New LCD display increases brightness and improves contrast
- Super Red Hot colorization alerts firefighters to areas of intense heat
- Temperature measurement in numeric and relative heat indicator formats
- Optional Electronic Thermal Throttle enables firefighters to isolate heat sources
- A handle can be purchased additionally to allow users a different grip and optional Digital Video Recording (DVR) and/or Transmission

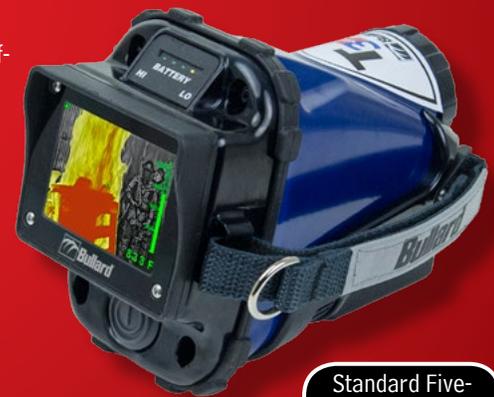
## T4X

The T4X combines advanced features and the industry's largest widescreen display along with the newest infrared engine technology for maximum thermal imaging performance. With all features standard, the T4X gives fire departments everything they'll need in a high performance thermal imager.

- 320 x 240 ultra-high resolution
- Equipped with ICE image processing technology for greater image clarity
- Extra-large 4.3" widescreen format on a new LCD display increases brightness and improves contrast
- Electronic Thermal Throttle enables firefighters to isolate heat sources
- Super Red Hot colorization alerts firefighters to areas of intense heat
- Temperature measurement in numeric and relative heat indicator formats
- 2x and 4x Zoom allows users to get closer to the action
- A handle can be purchased additionally to allow users a different grip and optional Digital Video Recording (DVR) and/or Transmission

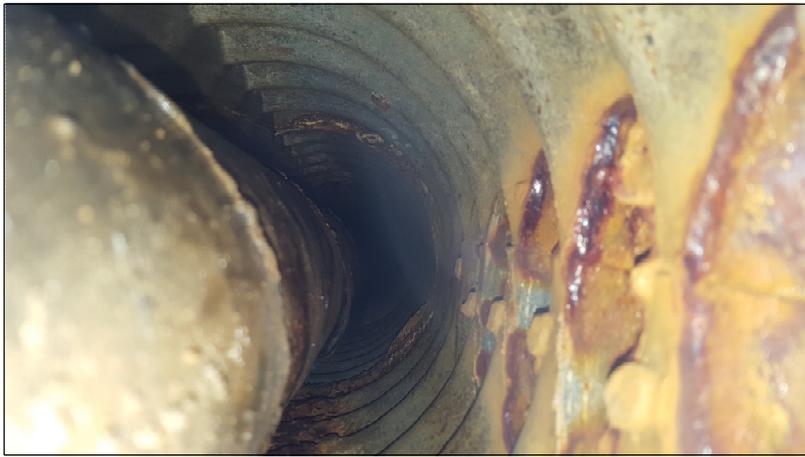
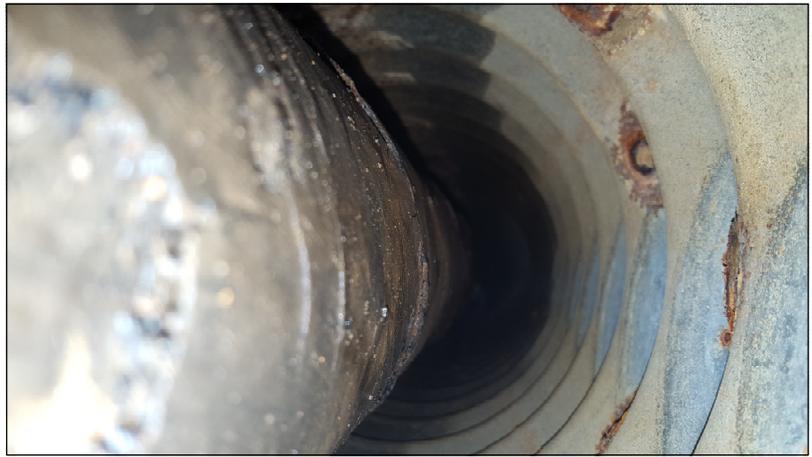
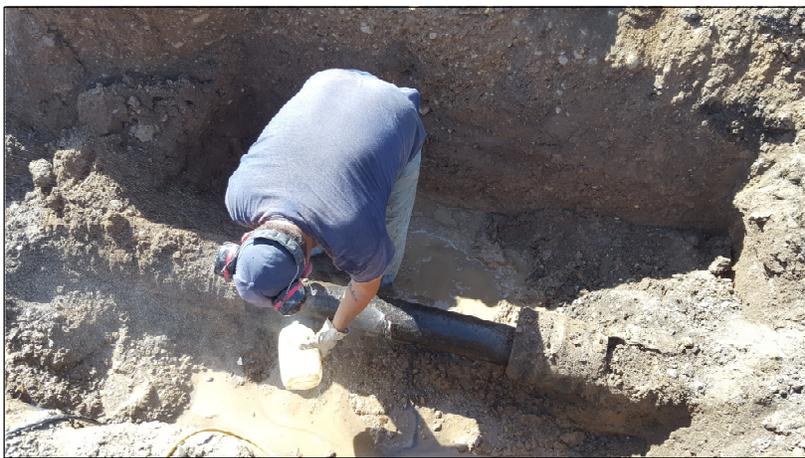
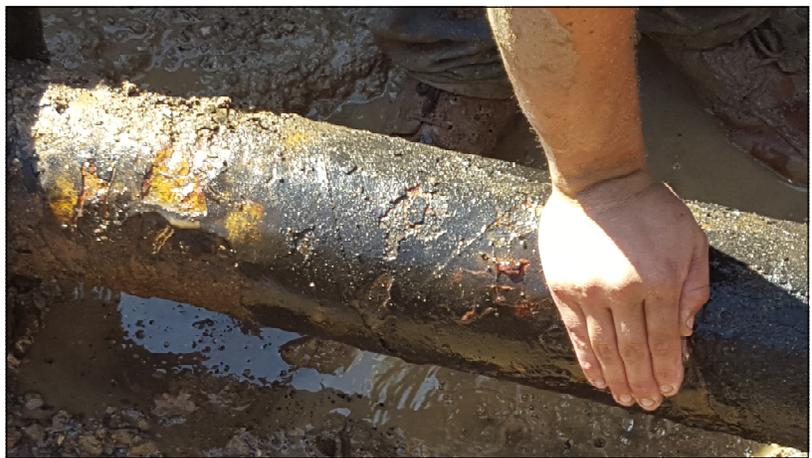
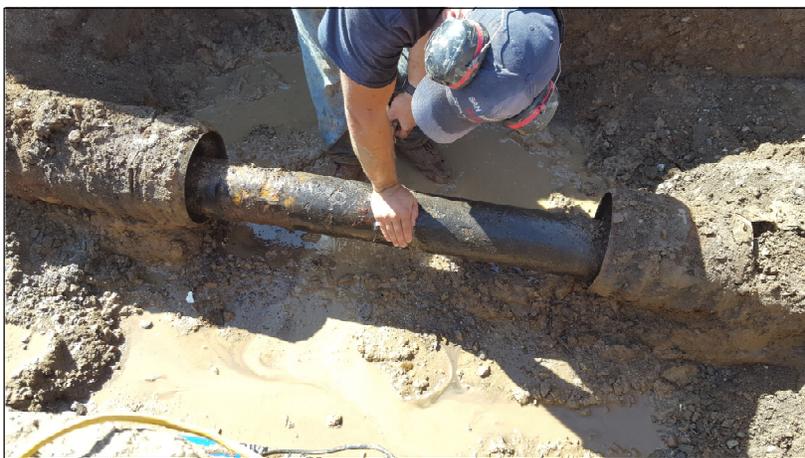
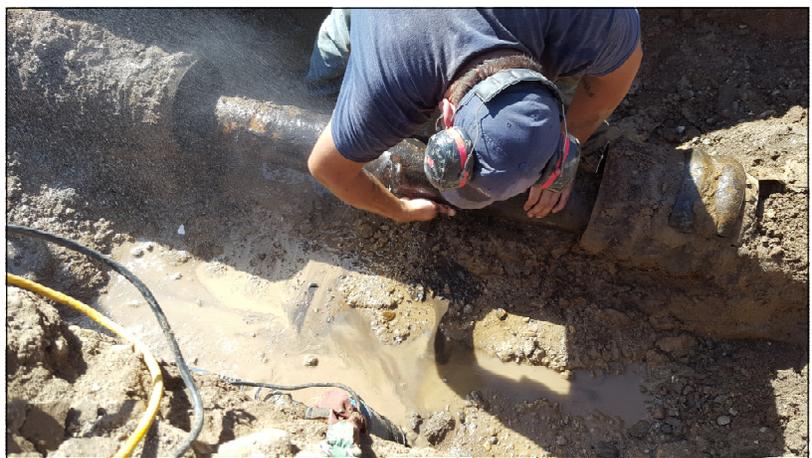
Attachment: Photos of 11<sup>th</sup> street and 10<sup>th</sup> street repairs

On September 9<sup>th</sup>, the District was alerted to a possible water leak on 11<sup>th</sup> street just east of the railroad tracks. After excavating the site, we found one leak on a 1940's era steel water line at the end of a corrugated steel sleeve. The steel water line is encased in a corrugated steel sleeve and extends beneath the railroad right-of-way. After patching that leak, District Utility Services crew also discovered a second leak on the same line, west and closer to the rail right-of-way. After exposing that leak, during the attempt to do repairs, a new leak developed and was repaired. A determination was made that the best course of action was to replace the entire section (21') of the steel water main that was exposed at that point as the entire length was showing signs of imminent failure.

After removing and replacing the section we extracted the water line from the sleeve and found that almost everywhere that the water line was touching the sleeve it had damage and was showing signs of failure.

It can be inferred from this repair that the entire length under the railroad right-of-way and tracks may be in the same condition. An observation of the existing water main condition shows that the entire length (approximately 170') could fail at any time due to same deterioration. Staff is convinced that there are leaks in other locations which are not yet evident.

After site excavation of this location, the same 1940's era steel pipe in a corrugated steel sleeve (same conditions as the water main crossing at 11<sup>th</sup> Street and the railroad line) was discovered by Utility crew. At this location, the water line is also touching the corrugated steel sleeve and shows signs of failure. This length of pipe travels under Mission street from west to east (approximately 100'). It is safe to assume the entire length is likely in the same poor condition and possible failure(s) could occur.

Since the water mains are in sleeves it is possible to pull out the existing line and insert a new HDPE or welded steel line. This repair option is presented for discussion but based on field observations, the casing at both water main locations has reached the end of useful life and must be removed and replaced.

- This option will only work if the sleeve is not compromised, the sleeve may already be collapsed or when the old line is pulled out a collapse may occur which will permanently destroy the sleeve and may cause collapse of the surface structures (IE the road way or rail bed). This corrugated metal casing is at the end of its useful life, and based on field observations replacement is required.

This option is likely the best and only option for the 11<sup>th</sup> street replacement under the railroad tracks.

The 11<sup>th</sup> Street water main replacement has one feasible option, jack and bore installation with abandonment of the old casing/water main, this is likely the only option for replacement that will conform to the UPRR requirements

The 10<sup>th</sup> Street water main replacement has 2 viable options, jack and bore installation and open trench. Open trench is the least costly of these two construction methods. To determine if open trenching construction will be supported by County Public Works, a consultation meeting should be held with a follow-up to Committee. Such a meeting may help determine which course of action for this water main would be appropriate, however, this initial consultation was awaiting a decision on changing District Engineer services.

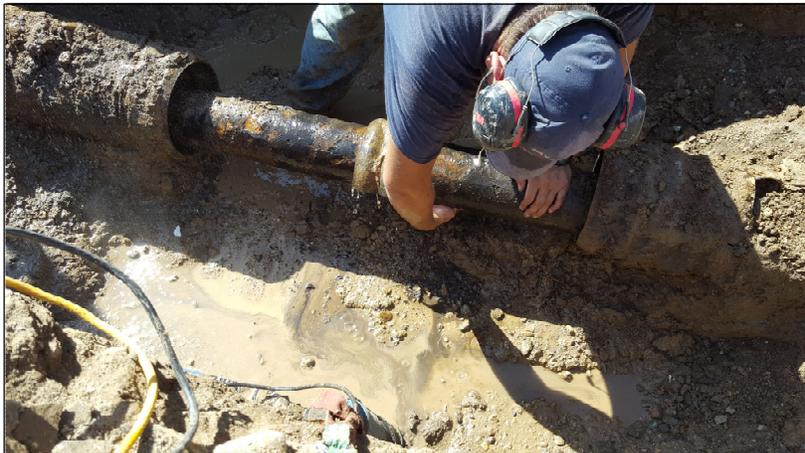
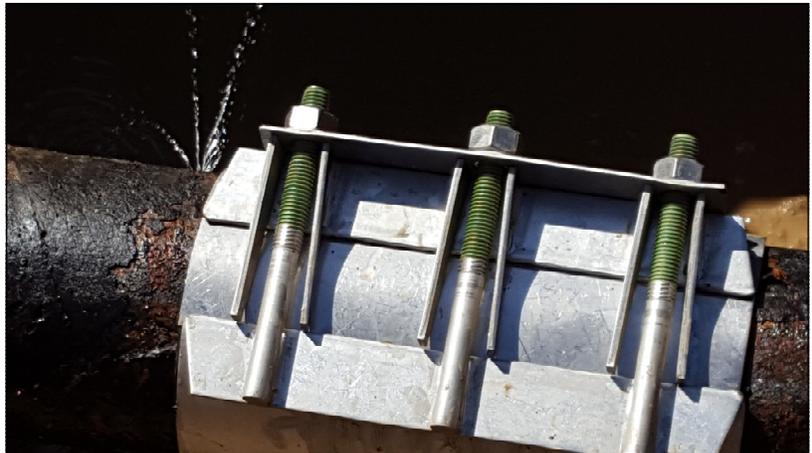
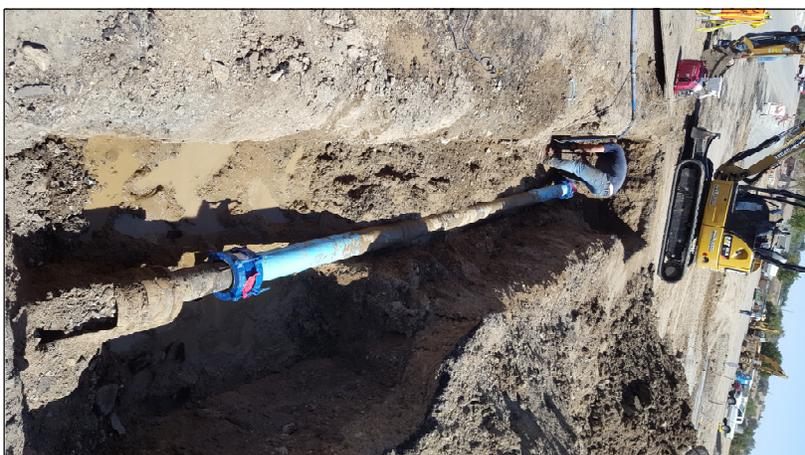
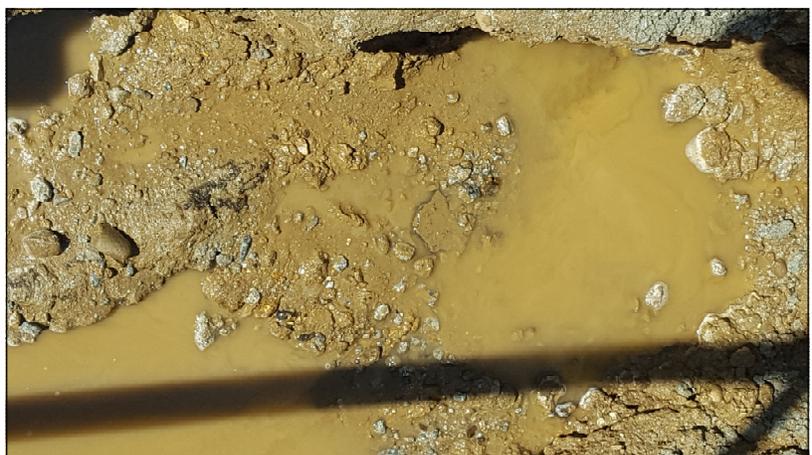
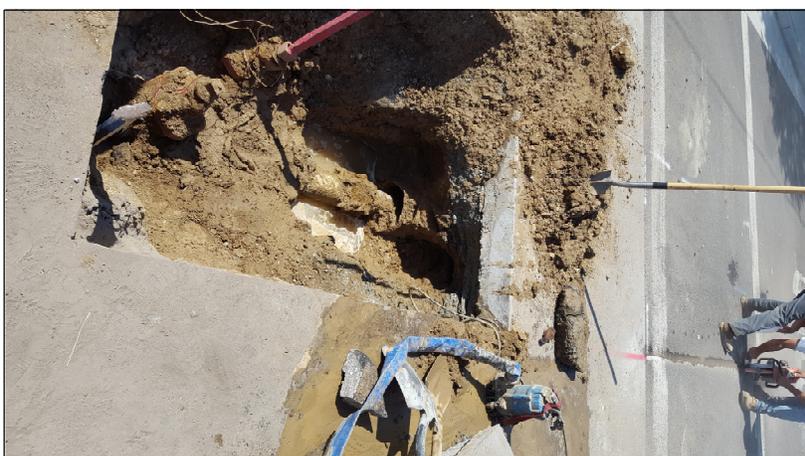
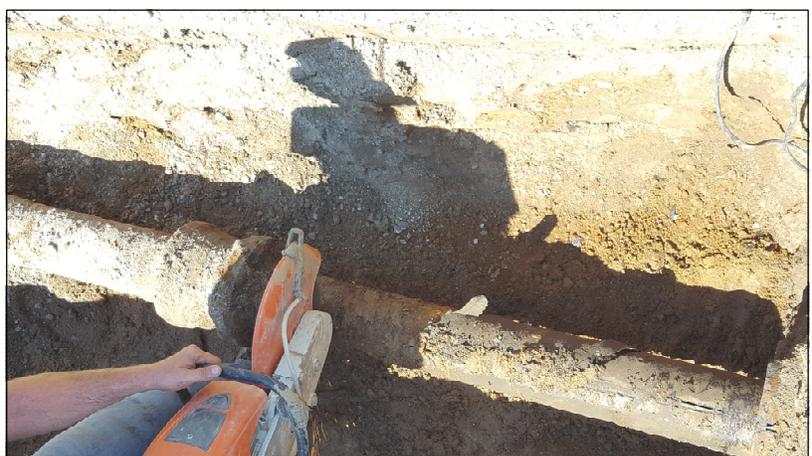
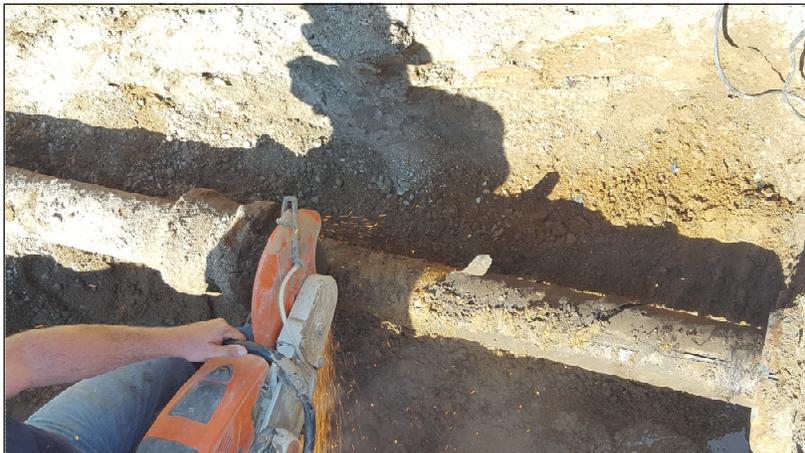
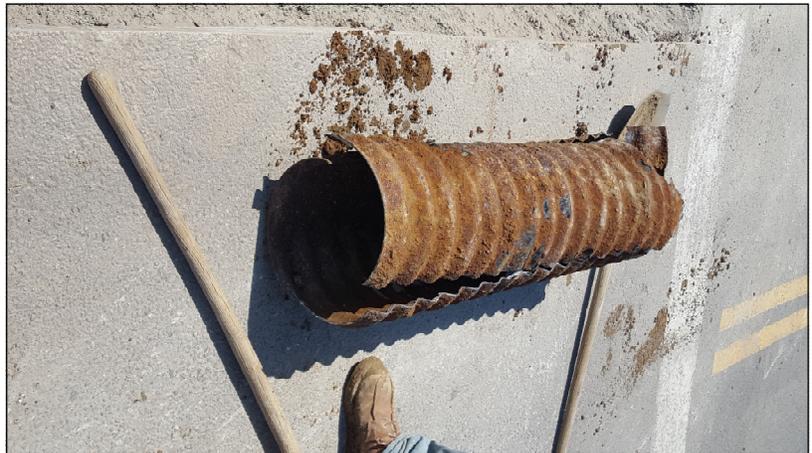
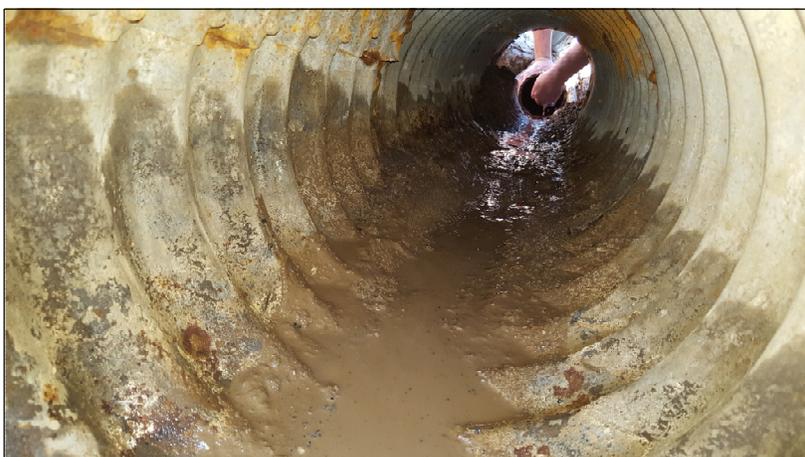
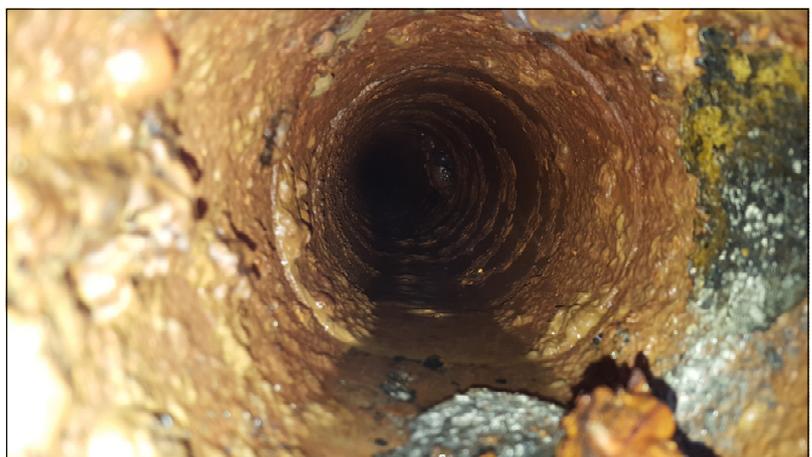
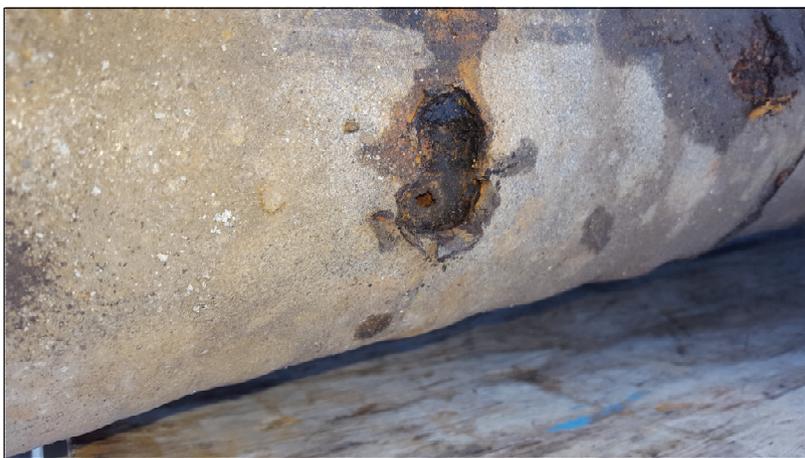
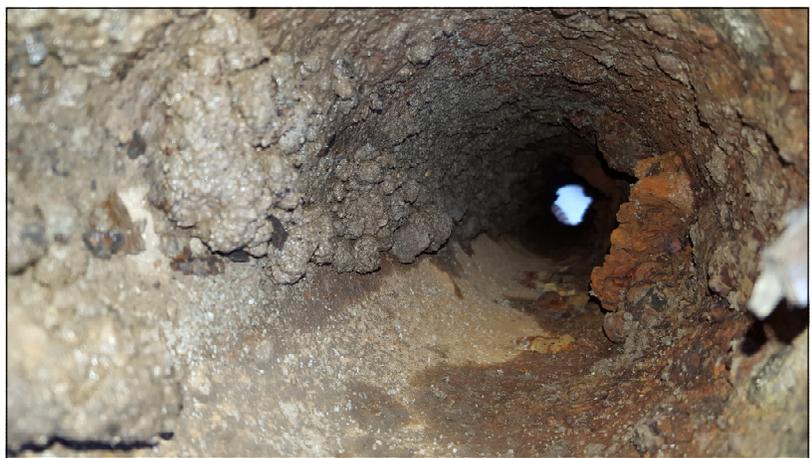
On September 7<sup>th</sup>, District Utility Services crew also discovered a main leak at the intersection of 10<sup>th</sup> and Mission Streets. Repairs were delayed until September 20<sup>th</sup> when a contractor could excavate the site. This delay was possibly due to old concrete highway was in that location. This material would require additional equipment to perform excavation work. The District's purchase of a mini-excavator had not arrived yet.

**A)** Replace the main in the existing sleeve.

**B) Replace the main by bore and jack**

**C) Conventional open trench replacement**
